CONNECTICUT RIVER BASIN  
SPRINGFIELD, MASSACHUSETTS

MILL POND DAM  
MA 00575

PHASE I INSPECTION REPORT  
NATIONAL DAM INSPECTION PROGRAM

NOVEMBER 1978

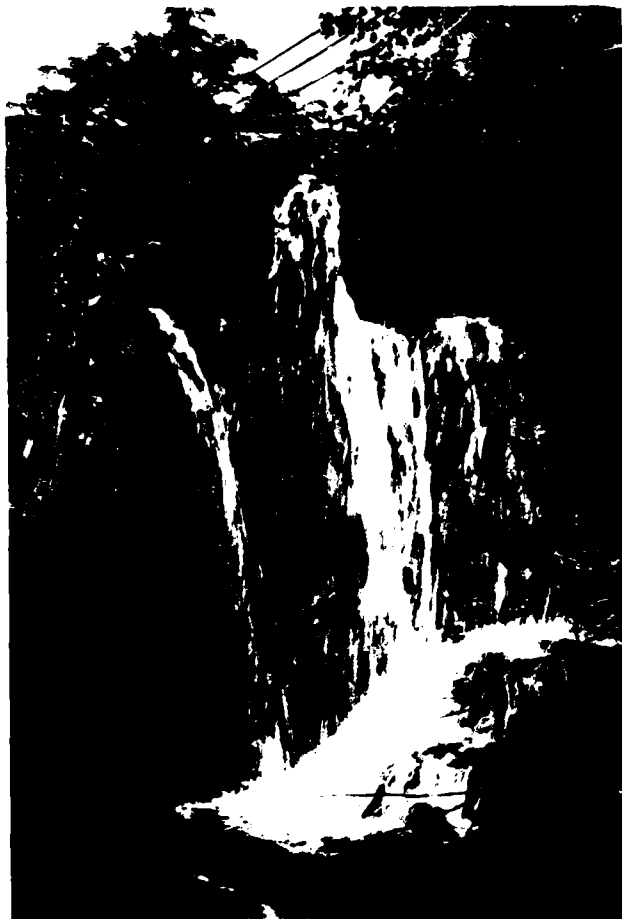
9. PRESSURE LEAKAGE THROUGH DAM NEAR LEFT ABUTMENT OF DAM.

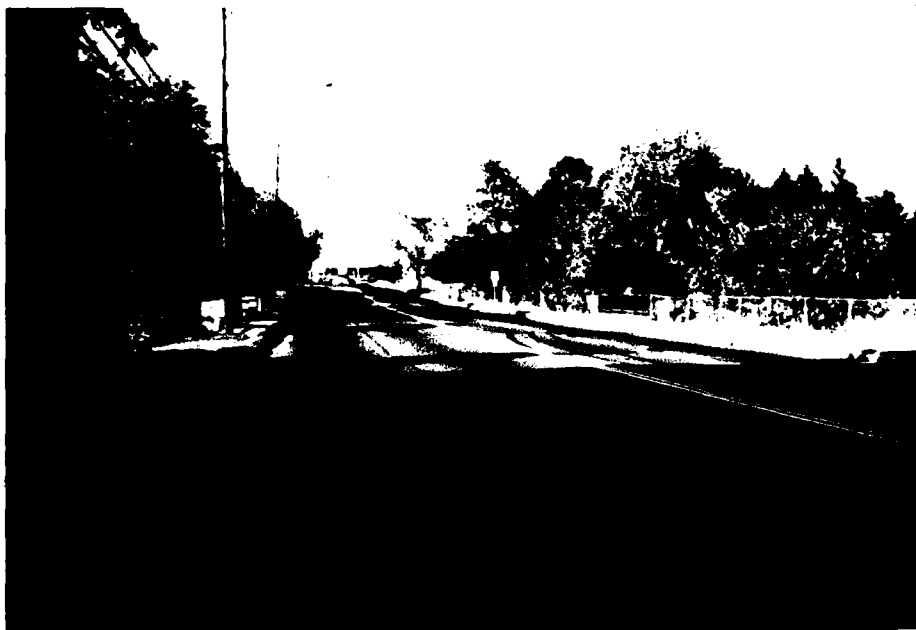
6. LOOKING NORTH TOWARDS MILL POND CULVERT ALONG PARKER STREET.
